# Arboricultural Assessment and Report

18 Mason Street, Warragul

Prepared for Housing Choices Australia

2 March 2023

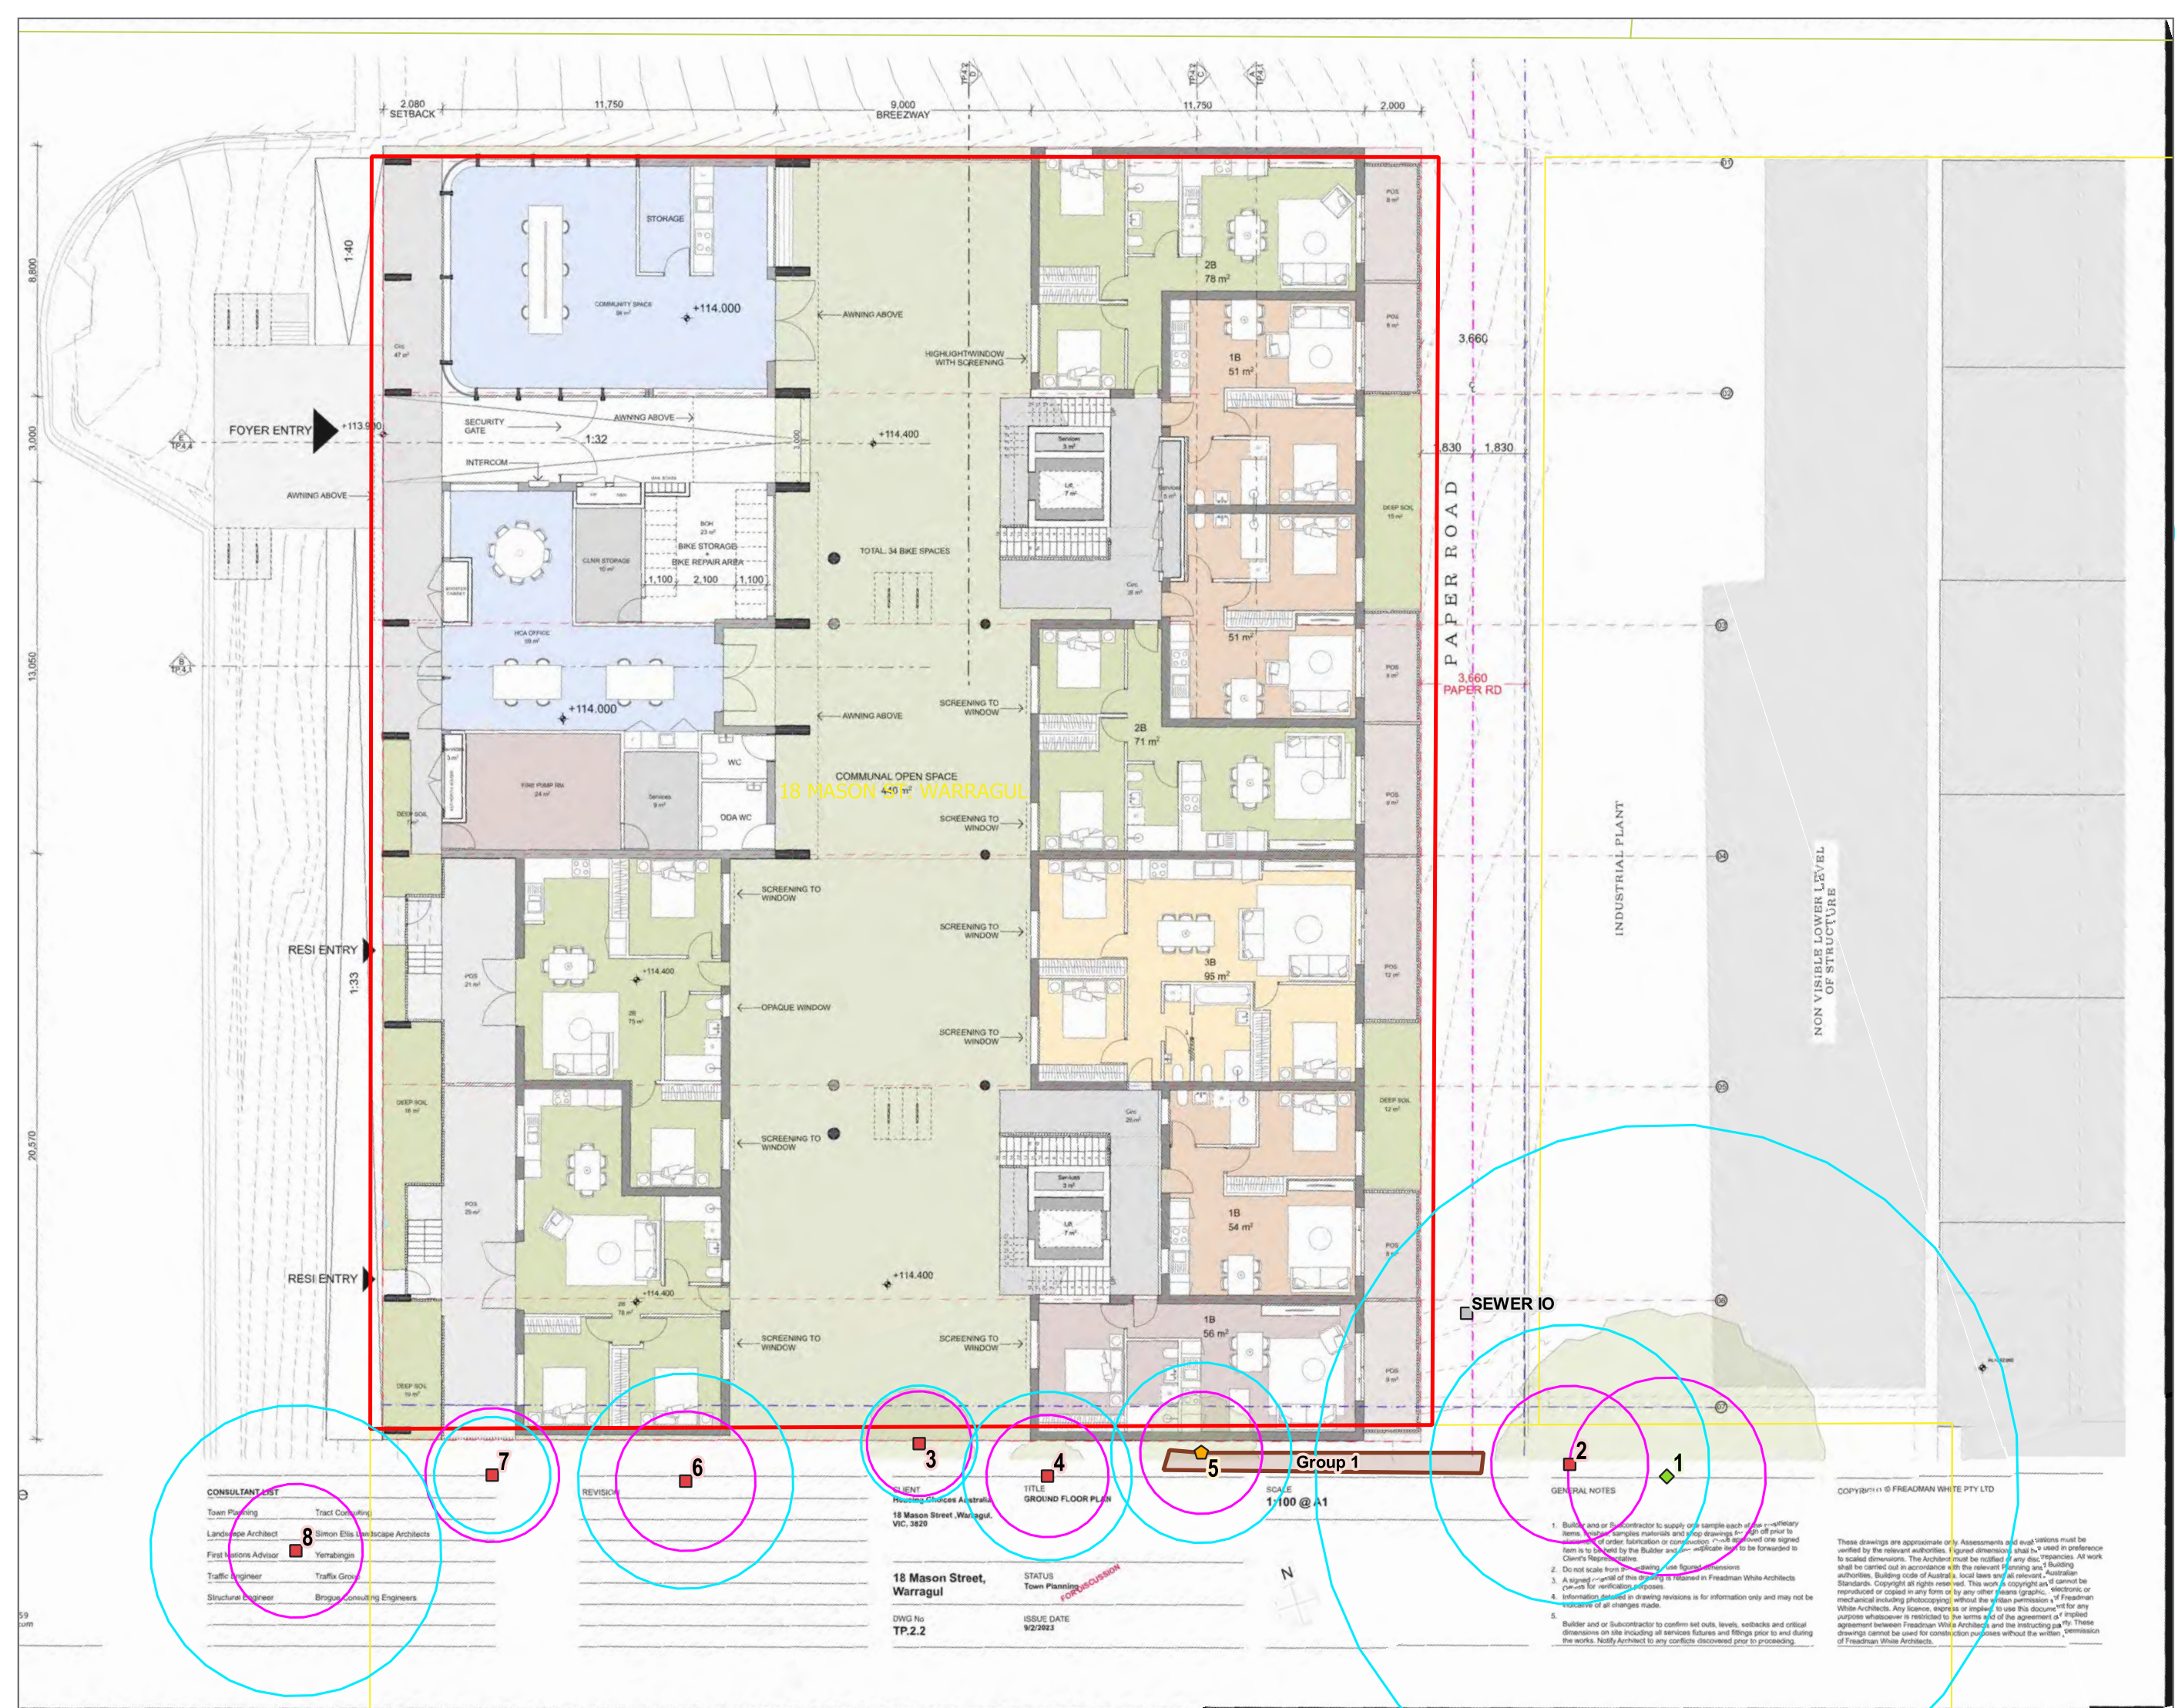
## Appendix 2B: Design Review – TPZ Impact Plan: 18 Mason Street, Warragul – Proposed

TPZ impact	Count	Tree numbers	comment
None	3	2, 8, G1	Tree 2 and Grp 1 unsuitable to retain.
Basement in TPZ <5%	1	1	Establish TPZ fencing 1 metre from basement footprint.
Basement in SRZ	5	3, 4, 5, 6, 7	Tree at risk of decline and failure. Trees generally unsuitable to retain
<b>Total</b>	<b>9</b>

- The trees can be successfully sustained with appropriate TPZ fencing established 1 metre back from the proposed basement footprint.
- The shared path to be constructed in the paper road to the east of the site will notionally encroach the TPZ also. The path must adopt a shallow profile that does not require excavation greater than 100-150 mm depth for compacted sub-base material, in order to avoid any potential root damage. Any discrepancy between the finished surface level and natural ground would be made up with either mulch or uncompacted top-soil.

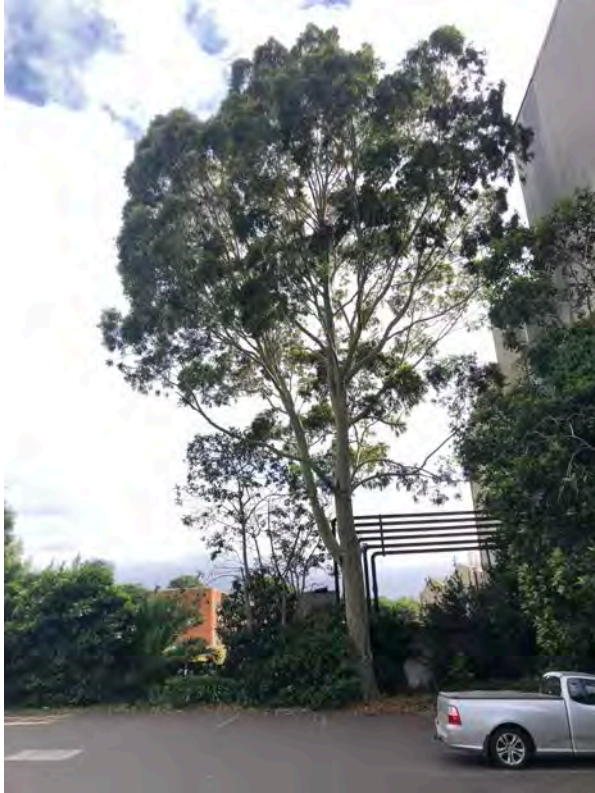
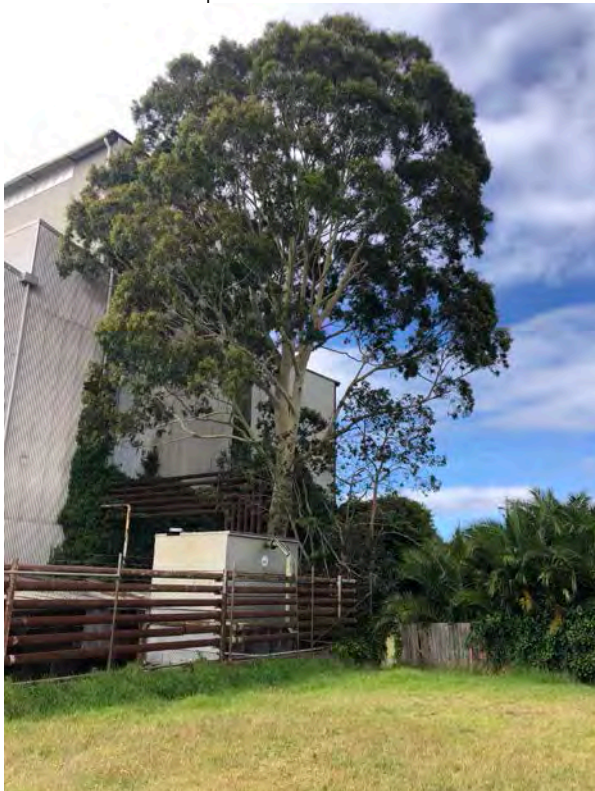
Tree no: 1. *Corymbia maculata* (Spotted Gum). Maturing, Victorian native.  
Permit: Neighbour's tree  
Health: Good. Structure: Good. Arb. rating: Mod.A.  
DBH: 101cm. TPZ: 12.1 (m radius). 2m deep Concrete pit 1 metre Nth extends ~5m west will have impeded root growth towards subject site.  
Damaged kerb 0.5m Sth, Preferential root growth evident below asphalt carpark to SE where water collects. Weed infested with Coprosma, Ivy, Blackberry, Holly, Phoenix, Sweet Pittos, Privet  
Impact: Basement - 4.0%, POS - 2.65%, ground - 1.14%.

Tree 1 viewed from carpark

Tree 1 viewed from subject site

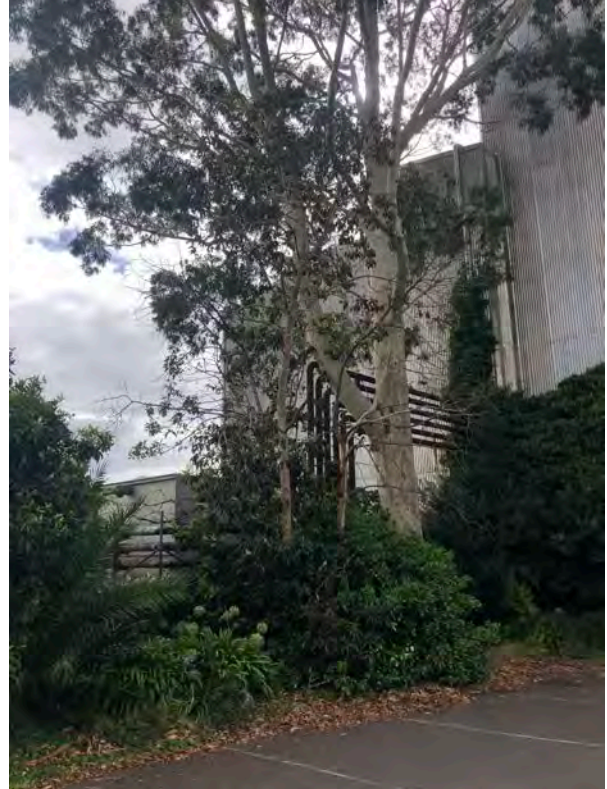
Tree no: 2. *Lophostemon confertus* (Brush Box). Early-mature, Australian native. Permit: Neighbour's tree  
Health: Poor. Structure: Poor. Arb. rating: Low.  
DBH: 24, 20, 19, 16, 9cm. TPZ: 4.8 (m radius). Multi-stemmed, Stump re-sprout, Weed infested. 2 x 16cm stems dead. Adjacent to 2m concrete pit 1m Nth  
Impact: NA.

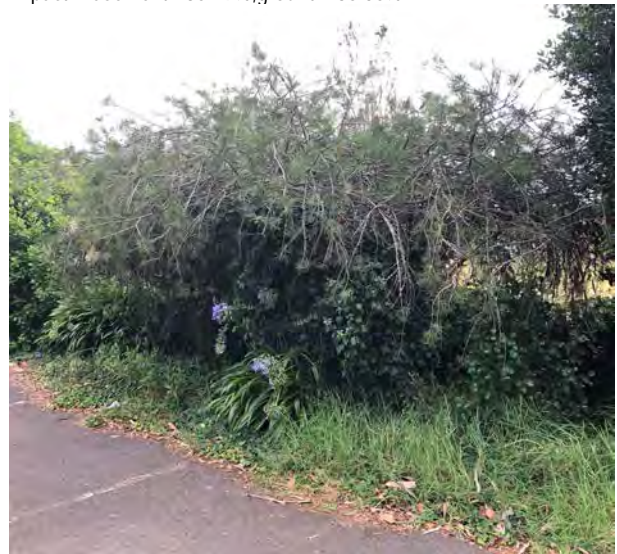
Tree no: 3. *Callistemon citrinus* (Crimson Bottlebrush). Maturing, Victorian native. Permit: Neighbour's tree  
Health: Fair. Structure: Fair to Poor. Arb. rating: Low.  
DBH: 10, 9, 9, 8, 7cm. TPZ: 2 (m radius). Neighbour's Multi-stemmed Shrub, Ivy infested  
Impact: Basement - 35.19%, ground - 36.86%.

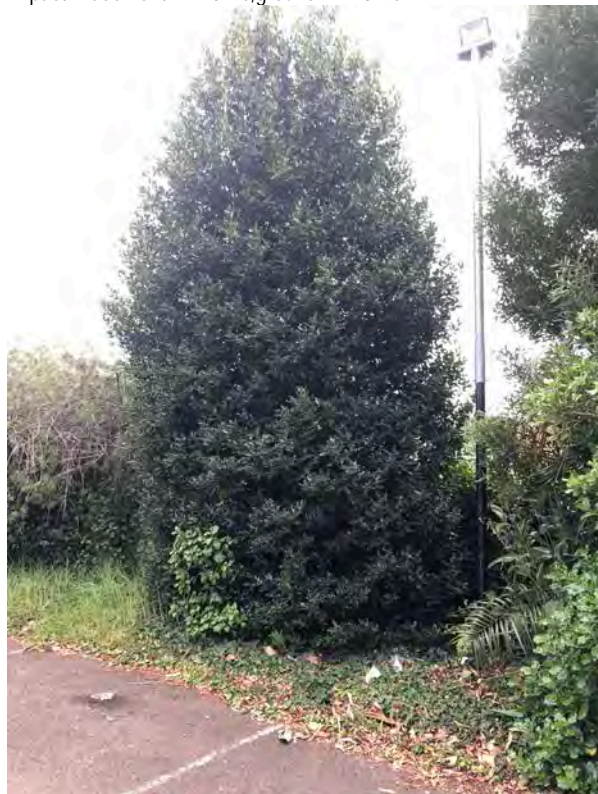
Tree no: 4. *Ilex aquifolium* (English Holly). Early-mature, Exotic evergreen. Permit: Neighbour's tree  
 Health: Fair. Structure: Fair to Poor. Arb. rating: Low.  
 DBH: 12, 11, 10, 10, 10 (est.)cm. TPZ: 2.9 (m radius). Multi-stemmed, neighbour's tree, weed infested, woody weed sp  
 Impact: Basement - 17.02%,ground - 17.82%.

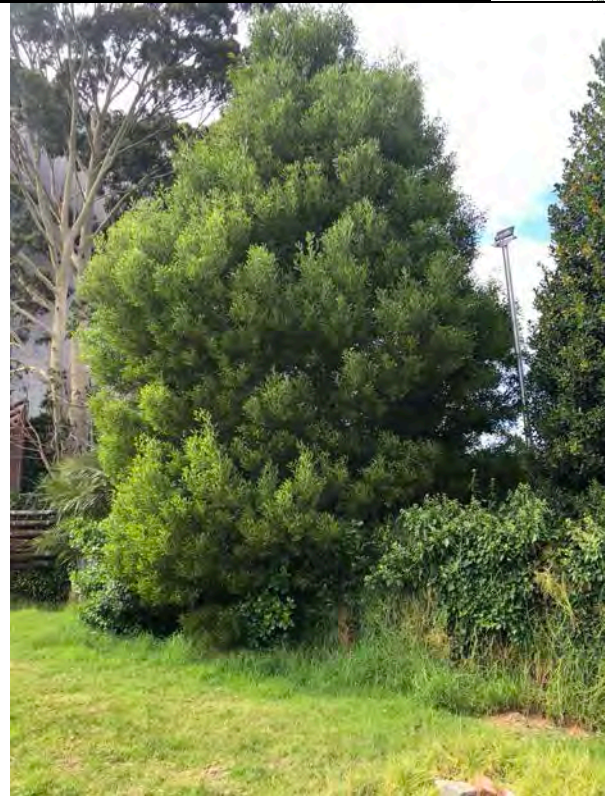
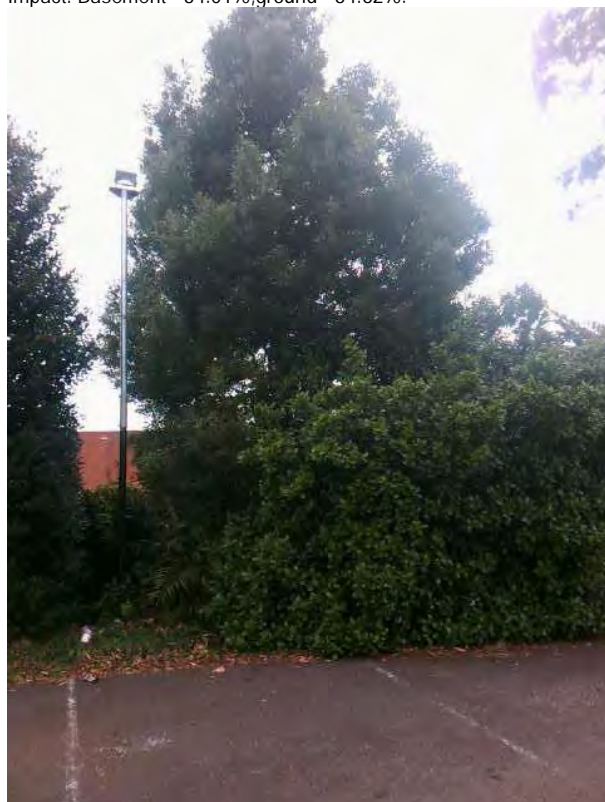
- Tree 5 was attributed an arboricultural rating of Moderate C, displaying generally typical health for the species but having crown asymmetry towards the north (subject site) and potentially being a re-sprout from an 80cm decayed Blackwood stump at the base.

View of Tree 5 from subject site

Tree no: 5. *Acacia melanoxylon* (Blackwood). Early-mature, Indigenous. Permit: Neighbour's tree  
 Health: Fair. Structure: Fair. Arb. rating: Mod.C.  
 DBH: 26cm. TPZ: 3.1 (m radius). Neighbour's tree, Weed infested. Possible stump re\_sprout, ~80cm decayed stump at base south.  
 Overhangs boundary by ~3m  
 Impact: Basement - 34.01%,ground - 34.62%.

- 6.4 Based on the perceived impacts to Tree 5 and the other low rated trees within the vegetation strip abutting the southern boundary it is recommended that removal and replacement of the Blackwood, Tree 5 and all of the other weed or poor quality trees is negotiated with the land-owner, on the basis that the boundary is so degraded, overgrown and weed infested that it is necessary for any future development to improve the fence and boundary plantings.
- Future planting species selection should be from trees that will tolerate shading and maintain a relatively narrow upright form.

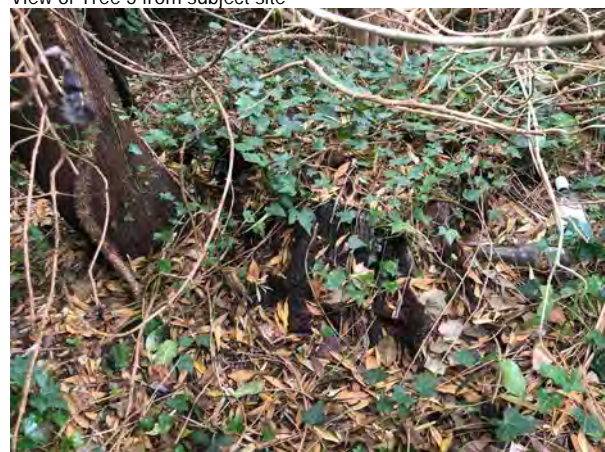
View of 80cm decayed stump at base of Tree 5

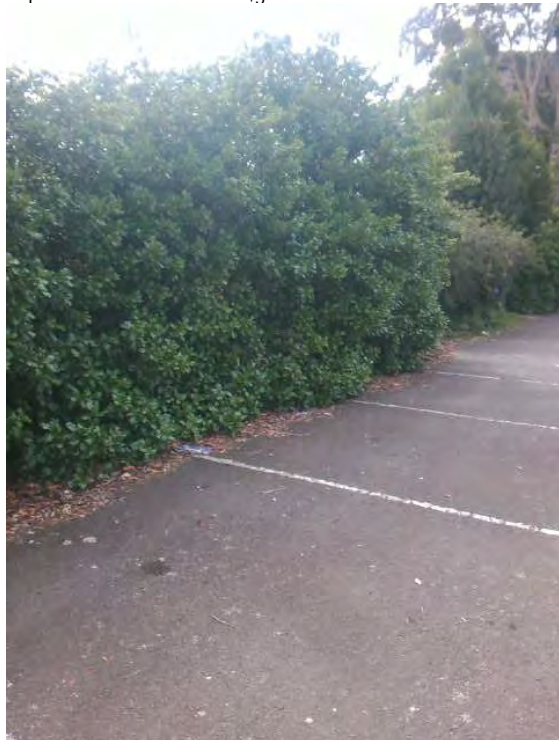
Tree no: 6. *Coprosma repens* (Mirror Bush). Maturing, Exotic evergreen.  
 Permit: Neighbour's tree  
 Health: Fair. Structure: Fair to Poor. Arb. rating: Low.  
 DBH: 15, 15, 14, 13, 12cm. TPZ: 3.7 (m radius).  
 Impact: Basement - 20.97%,ground - 22.08%.

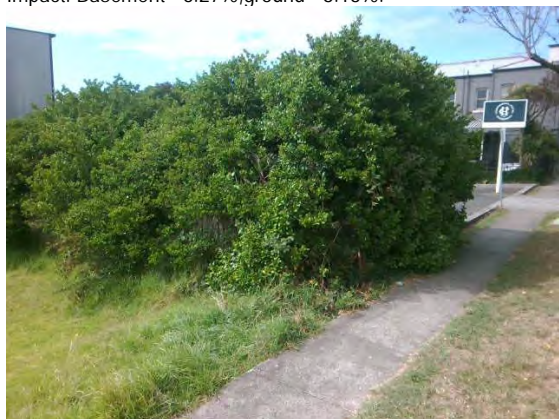
Tree no: 7. *Coprosma repens* (Mirror Bush). Maturing, Exotic evergreen.  
 Permit: Neighbour's tree  
 Health: Fair. Structure: Fair to Poor. Arb. rating: Low.  
 DBH: 11, 9, 8, 8, 7cm. TPZ: 2 (m radius). Neighbour's Multi-stemmed  
 Woody weed tree, hangs 1m over fence  
 Impact: Basement - 6.27%,ground - 8.13%.

Viewed from subject site

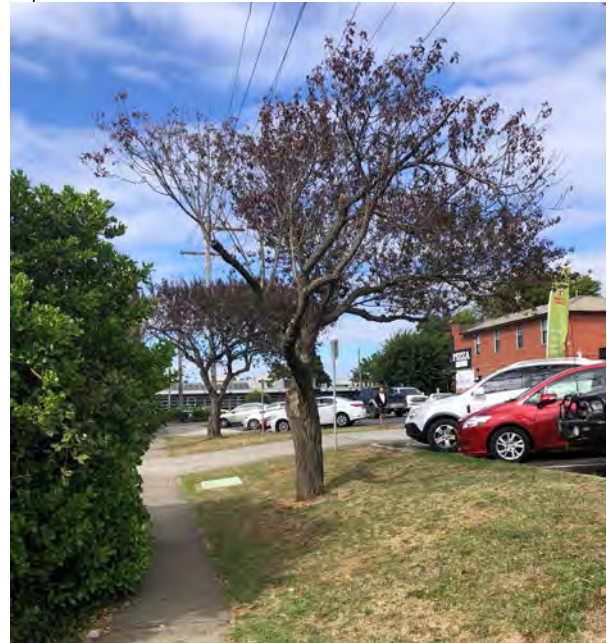
Tree no: 8. *Prunus cerasifera 'Nigra'* (Purple Leaf Cherry Plum). Over-  
 mature, Exotic deciduous. Permit: Neighbour's tree  
 Health: Fair to Poor. Structure: Poor. Arb. rating: Low.  
 DBH: 42cm. TPZ: 5 (m radius). Street tree, Past powerline clearance, Past  
 stem failure w Trunk decay, Over-extended limbs developing-SW.  
 Future removal & new planting scheme likely,  
 Impact: NA.

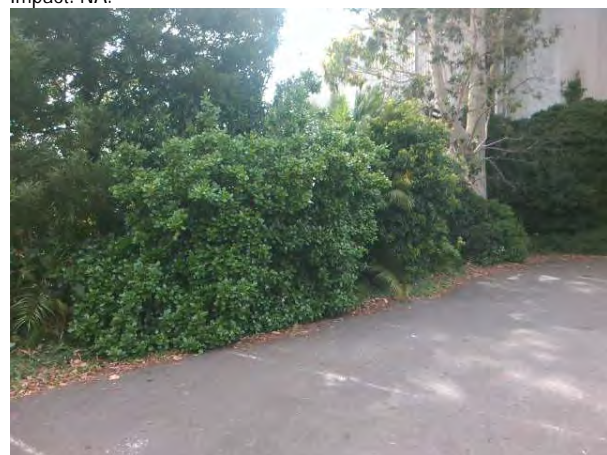
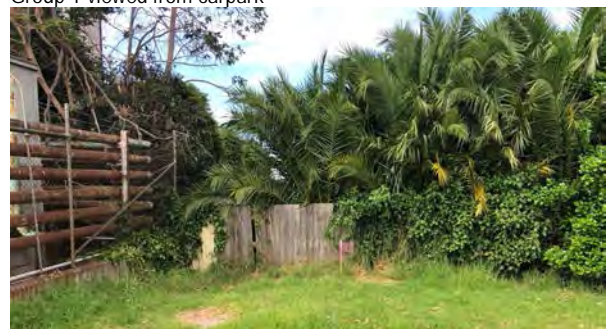
Tree no: Group 1. *Coprosma repens*,  
*Phoenix canariensis*, *Pittosporum undulatum* (Mirror Bush, Canary Island  
 Date Palm, Sweet Pittosporum). Maturing, Exotic evergreen, Exotic palm,  
 Victorian native. Permit: Neighbour's tree  
 Health: Fair. Structure: Fair to Poor. Arb. rating: Very Low.  
 DBH: 15cm. TPZ: 2 (m radius). Neighbour's Group of ~ 7 self-sown weed  
 trees, some multi-stemmed, all weed infested.  
 Impact: NA.

Group 1 viewed from carpark

Group 1 viewed from with subject site
